# Systems and Concepts for Repair and Strengthening

## Systems and Concepts for Repair and Strengthening of Bridges and other Structures

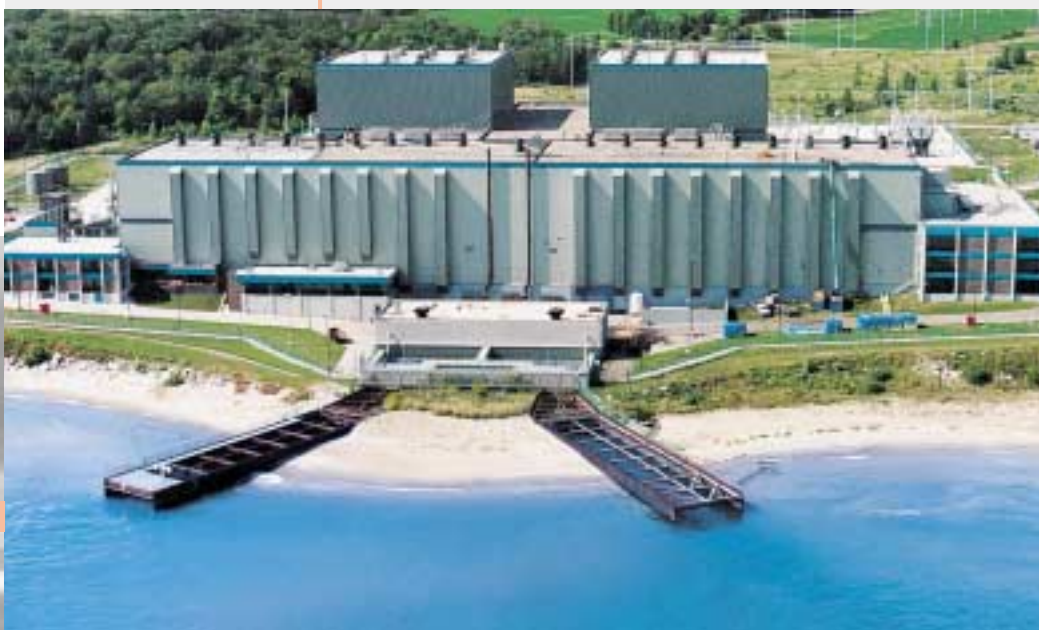
Inspection of the post-tensioning tendons of two containment structures was carried out according to the safety specifications of the US Nuclear Regulatory Commission. Both visual and physical inspection (lift-off, detensioning and tensile tests) were carried out on selected tendons from all tendon groups (hoop, vertical and dome tendons).

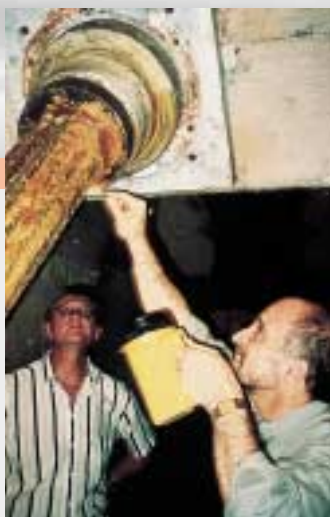
### Autopista del Sol, Cable Stayed Bridges, Mexico

Four cable stayed bridges between Cuernavaca and Acapulco were inspected. First a detailed inspection program with a numerical and qualitative rating system was developed. A detailed report on the quality and state of the main parts of each bridge, especially superstructures, pylons and stay cables as well as recommendations on remedial measures were proposed to the owner.

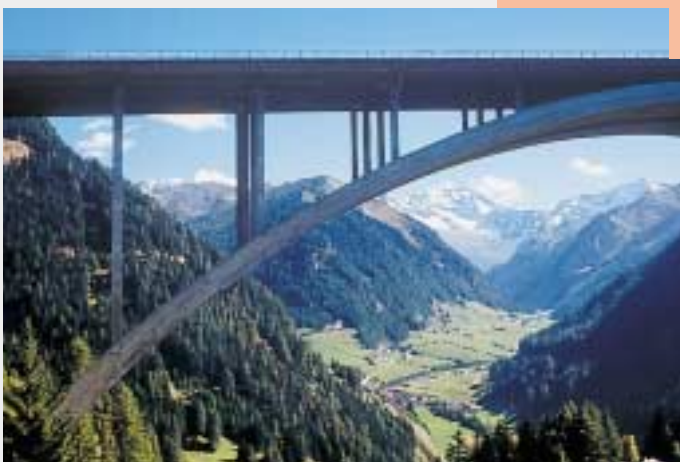
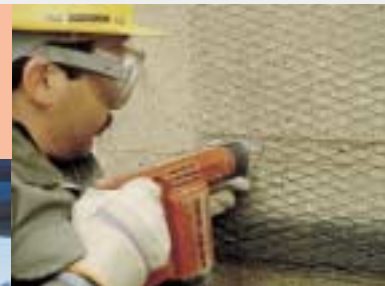
The concrete of the 50 m high piers at the buttresses of the 180 m long arches was highly chloride contaminated up to a depth of 60 mm due to twenty years of exposure to de-icing salts. CP was applied to 1,500 m<sup>2</sup> of the concrete surface, as only this measure did not jeopardize the load-bearing capacity and stability of the bridge. Efficiency and performance of the CP system can be monitored at any time through potential measurements.

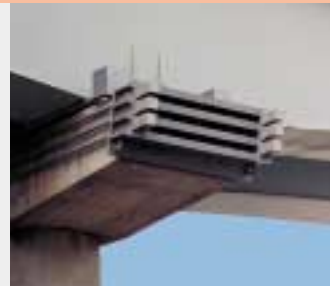
### MRT rapid transportation network, Muza Line, Taipei, Taiwan

In 1994 cracks were discovered in the concrete corbelled pier caps of the Muza line steel girder viaduct. The emergency repair scheme consisted of placing external  $\varnothing 36$  mm DYWIDAG bar tendons (THREADBAR®) on both sides of the pier cap. These were anchored in steel grillages at each end of the caps and were supplied with DYWIDAG double corrosion protection system. All exposed steel parts of the grillages were protected by a three coat paint system. On selected tendons permanent load cells were installed to monitor the prestressing forces.

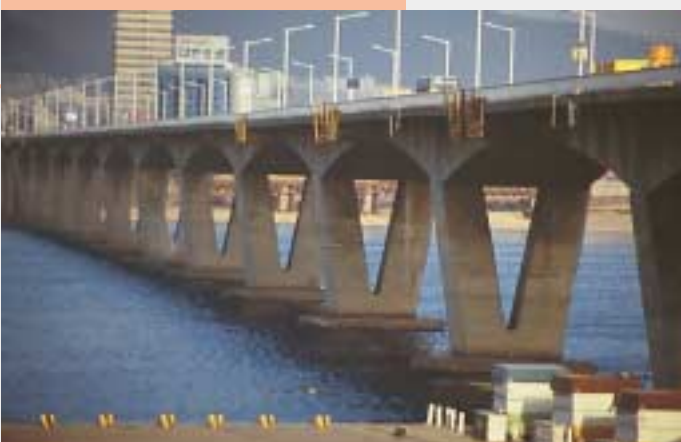
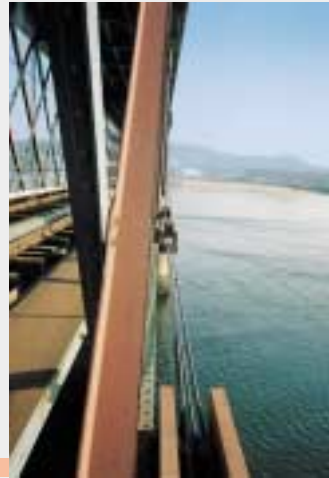
The 1,120 m long bridge over the Han River was completed in 1981. Because of inaccurate calculations of prestressing losses and deflections caused by creep and shrinkage of concrete, additional deflections of up to 30 cm occurred. These resulted in 5 cm to 20 cm sagging at the hinges. The DSI rehabilitation concept called for external tendons, which on the one hand slightly reduced deflections and on the other strengthened the structure. The remaining sag could be eliminated by an additional asphalt layer. Twelve 19 x 0.6" DYWIDAG tendons were applied in each cantilever and anchored in new concrete buttresses cast inside the box girders. These were connected to the concrete of the existing webs of the box girder through friction created by the means of short  $\varnothing$  36 mm DYWIDAG smooth bar tendons.

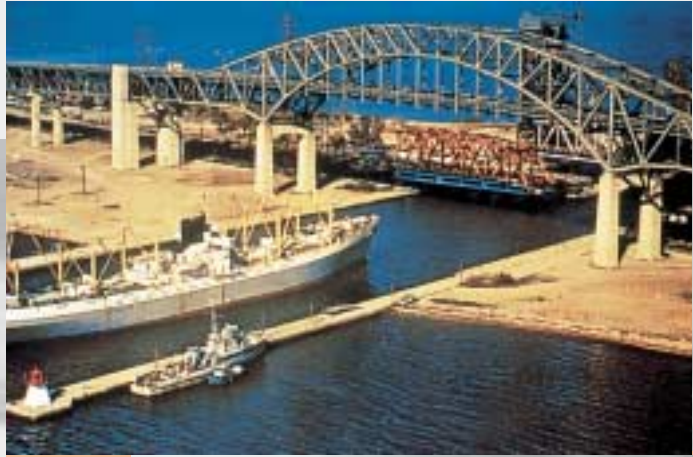
The three main spans (84-151-84 m) consist of a continuous truss arch structure where the two longitudinal main trusses are connected by bracing bents and transverse floor trusses. These trusses support longitudinal deck stringers which in turn support a reinforced concrete deck. The transverse floor trusses consist of standard structural steel shapes riveted and bolted together. The increased loading resulted in significant overstressing of the transverse floor truss members. These trusses were strengthened by external post-tensioning using  $\varnothing$  36 mm DYWIDAG bars (THREADBAR®) and a limited addition of new structural steel. This method allowed a minimal number of members to be dismantled and eliminated the need for strict dimensional tolerances that would be required with the addition or replacement of truss members. The selected draped tendons were anchored in the deck slab to maximize their effectiveness. A unique steel plate assembly was bolted to the truss joint at the deviation point of the tendon to anchor the bars and transfer the tendon force to the truss. The bars were protected by a three coat zinc/vinyl paint system.

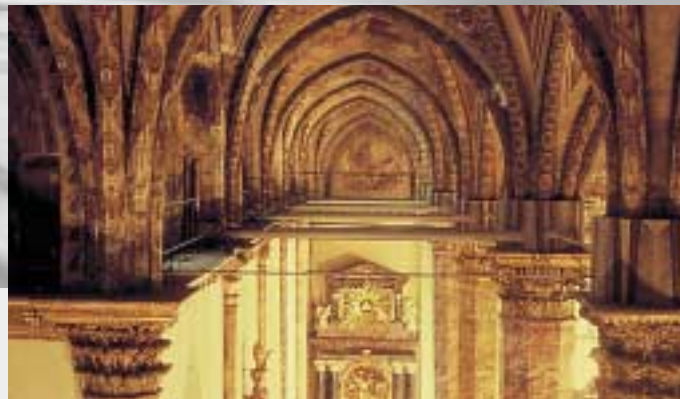
The San Lorenzo Cathedral was built between the 14th and 15th centuries. Already in 1633-1641 important consolidation works had been carried out, since, because of the weight of the roof, the columns and the walls had diverged. Seismic movements in 1983 caused further damage, thus endangering the stability of the monument. A new consolidation and restoration project was decided after a thorough historical survey of the original and subsequent static behavior of the structure. The twenty-three timber roof trusses were reinforced by strengthening the joints with steel plates and bolts and by prestressing both

the lower tie beam and the central king post with two twin  $\varnothing 36$  mm DYWIDAG bars (THREADBAR®) each. The column capitals showed displacements of up to 26 cm. A new system of transverse and longitudinal ties made of DYWIDAG bars (THREADBAR®) was introduced into the columns and walls to prevent any side displacements. The transverse tie members were prestressed and tied back to the lateral walls in order to apply to the whole structure a system of acting forces capable of counteracting the thrusts of the vaults.

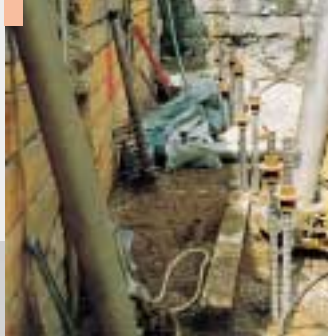
**Grandhotel  
Taschenbergpalais  
Kempinski, Dresden,  
Germany**

Built between 1707 and 1711, and completely destroyed by fire in 1945, this baroque palace is now the site of a luxury hotel. During construction of a 4-storey underground garage, the existing south façade, with a total weight of approx. 1,000 t, had to be supported 18 m above the foundation level. GEWI® bars with various diameters were used as tensioning and securing members. For the deep foundation of the western wing of the palace, GEWI® piles were drilled through the old cellar. The bond length of the piles is between 7 and 12 m.

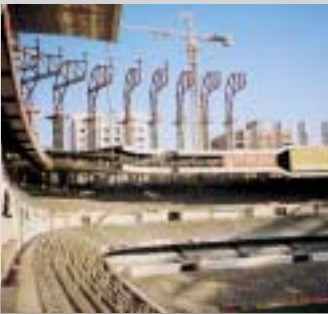
**Santiago Bernabéu Soccer Stadium, Madrid, Spain**

To increase the number of seats, the roof structure had to be raised. The existing reinforced concrete columns were strengthened and extended. They were lengthened by 12.5 m high steel columns with steel trusses cantilevering to 32 m and anchored by  $\varnothing$  40 mm GEWI® bars. Six GEWI® bars were anchored in each foundation, four on the tension side of the columns and two in the front. This arrangement carries the uplift forces from wind loads on the roof which was placed on top of the extended columns.

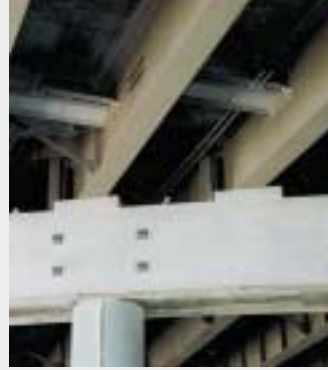
#### Elisian Viaduct, Los Angeles, California, USA

This bridge featured an old design concept of steel girders supported by concrete pier cap beams. The new retrofit design specified extensive use of bar tendons throughout the entire structure. The cap beam width was increased by adding new concrete on both sides. Transverse  $\varnothing$  32 mm DYWIDAG bars (THREADBAR®) connected new concrete to old. Steel girder stability was increased by adding special spreader beams bolted to the existing webs at several locations. Spreader beams placed in pairs were connected with an external restraint made of  $\varnothing$  32 mm bars (THREADBAR®).

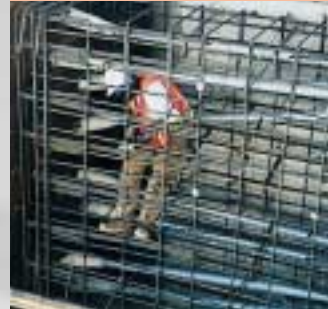
This very large superelevated freeway intersection required increased bearing capacity of the substructure to satisfy transversal flexural seismic demands. New post-tensioned transversal pier cap beams were added on each side and extended beyond the ends of the existing structure. Sixteen 15x0.6" tendons with DYWIDAG multiplane anchorages (MA) were installed. The upper tendons were conducted in pairs through holes drilled into the webs of the existing bridge girders. Large forces and confined space at some of the pier cap beams resulted in the first time use of DYWIDAG 37x0.62" strand tendons in California.

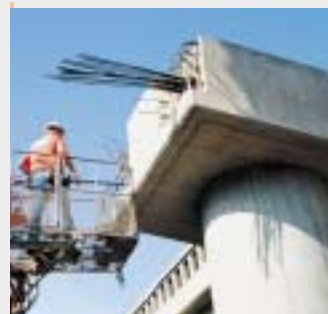
A new column was installed at the end of the pier cap beam to support an additional 3.6 m long concrete bolster, which increased flexural capacity. Post-tensioned strand tendons placed in parallel, on each side of the pier cap beam, connected new concrete to the existing box girders. A large steel bracket, attached to the bridge web at the tendon fixed end, allowed for uniform distribution of prestressing forces to the entire structure.

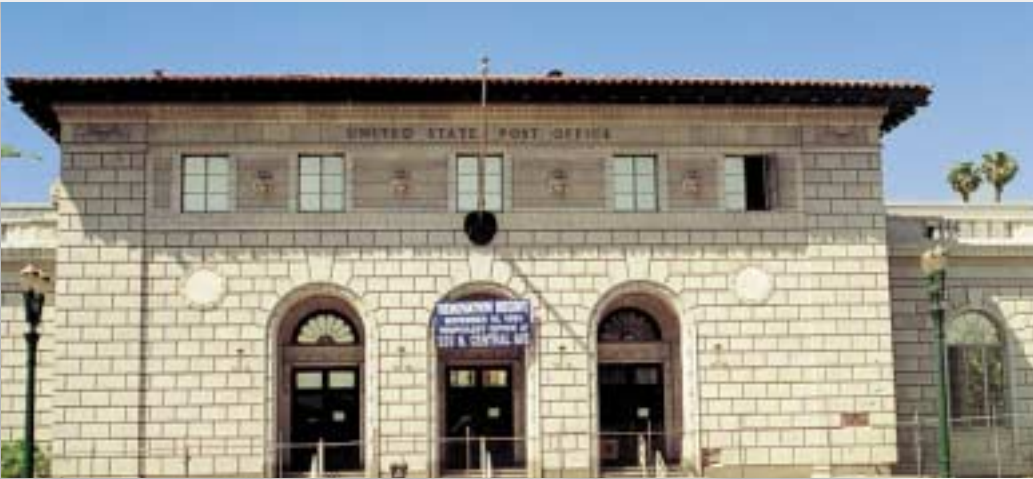
This historic landmark in the San Francisco Bay Area was built in 1914. Since the Loma Prieta (1989) earthquake, the steel frame building with masonry infill has been completely rehabilitated. Due to the limited strength of the existing structure, the seismic isolation concept was applied. At that time it was the tallest seismically isolated building of the world.

Special base isolators were placed under each building column. The foundation thickness above the seismic isolators was increased by adding new concrete around the perimeter of all footings. The interaction between old and new concrete was improved with ø 32 mm DYWIDAG transverse bar tendons (THREADBAR®) that passed through cored holes.

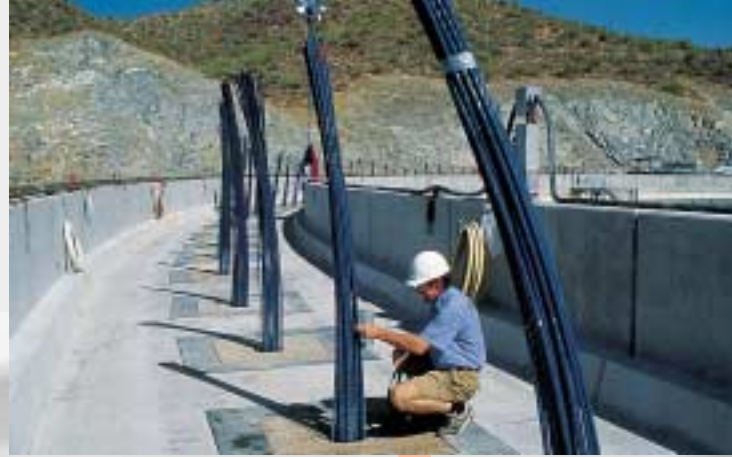
The double curvature thin arch concrete structure was built in the 1920's and is approximately 64 m high. Retrofitting became necessary to prevent a possible failure of the arch section, in which a separation along the joints during a major seismic event would occur. That was a very real danger as, during construction, the concrete cold joints had not been properly cleaned of laitance, resulting in weak joints with little or no cohesion between pour sections. The solution was to stabilize the dam by installing sixty-two 22 x 0.62" DYWIDAG rock anchors in the arch section to restore monolithic action. A further 22 anchors were installed in the left thrust block to provide for enhanced stability against sliding. As the anchors were to be stressed and remain ungrouted for a 100 days monitoring period, protecting the strands against corrosion

became an extremely important consideration. The superior corrosion protection and high bond capacity of the Flo-Bond epoxy coated strand provided the ideal solution for both requirements.

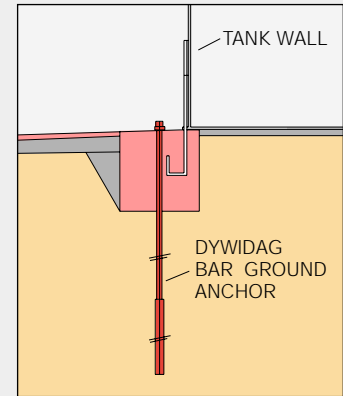
During a seismic event, the tank contents will move from side to side inducing dynamic uplifts on the tank foundations. To prevent damage at the foundation, high strength  $\varnothing$  25 mm and 32 mm DCP DYWIDAG bars (THREADBAR®) were used as tie down ground anchors around the steel tank perimeter.

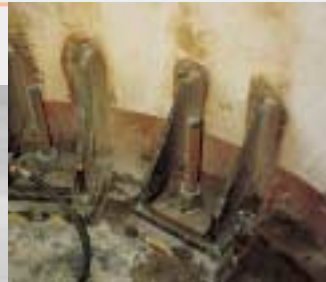
### Telecommunication tower, Diepenbeck, Belgium

The consultant decided to use DYWIDAG  $\varnothing$  32 mm bar tendons for rehabilitation of the existing anchors at the footing of the steel tower shaft. Since the foundation slab is supported by piles, the anchor plates for the lower anchorages could be mounted against the bottom side of the slab.

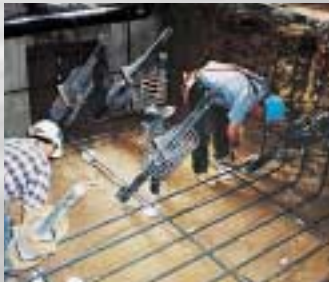
### Britannia Secondary School, Vancouver, British Columbia, Canada

In order to meet modern requirements on earthquake safety, this 70 year old building needed to be retrofitted. The designer chose high capacity  $\varnothing$  57 mm DCP GEWI® piles. Restricted by the low ceiling height in the building, the 15 m deep,  $\varnothing$  140 mm boreholes were drilled with a track-mounted hydraulic minidrilling rig. The anchors were coupled in sections from 2.7 m to 4 m. The tight restrictions of 2.7 m headroom, 0.60 m spacing at the pile head and pile inclinations of up to 40°, posed no problem for this very flexible installation method.

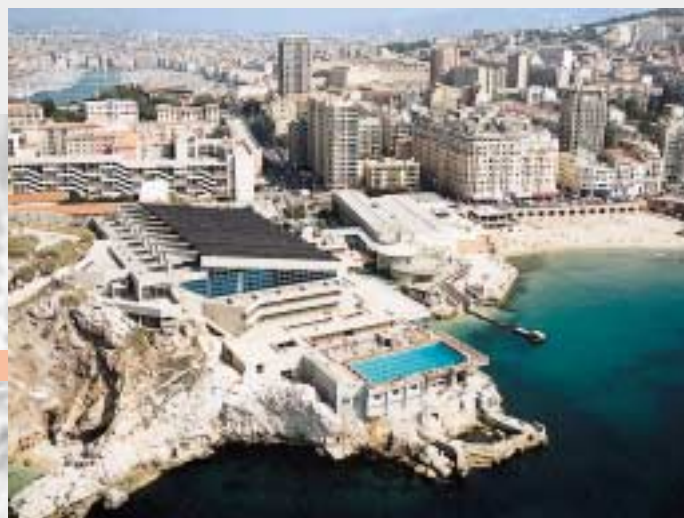
Before a new roof of this swimming hall could be constructed, the old roof had to be removed. Traditional in-situ demolishing would have incurred very high scaffolding costs and long roof-raising times. The DYWIDAG alternative to this method was to disconnect the roof from its supporting columns and move it in seven-meter long sections. Once the butt end of the building, had been cleared the roof was demolished. That proved to be by far the quickest and most cost-effective solution.
